The vacuum-circling process (VCP) has been developed to minimise and avoid disadvantages associated with common surface treatments with silica acid ester (ESE).

## 1. Vacuum-circling process (VCP) application

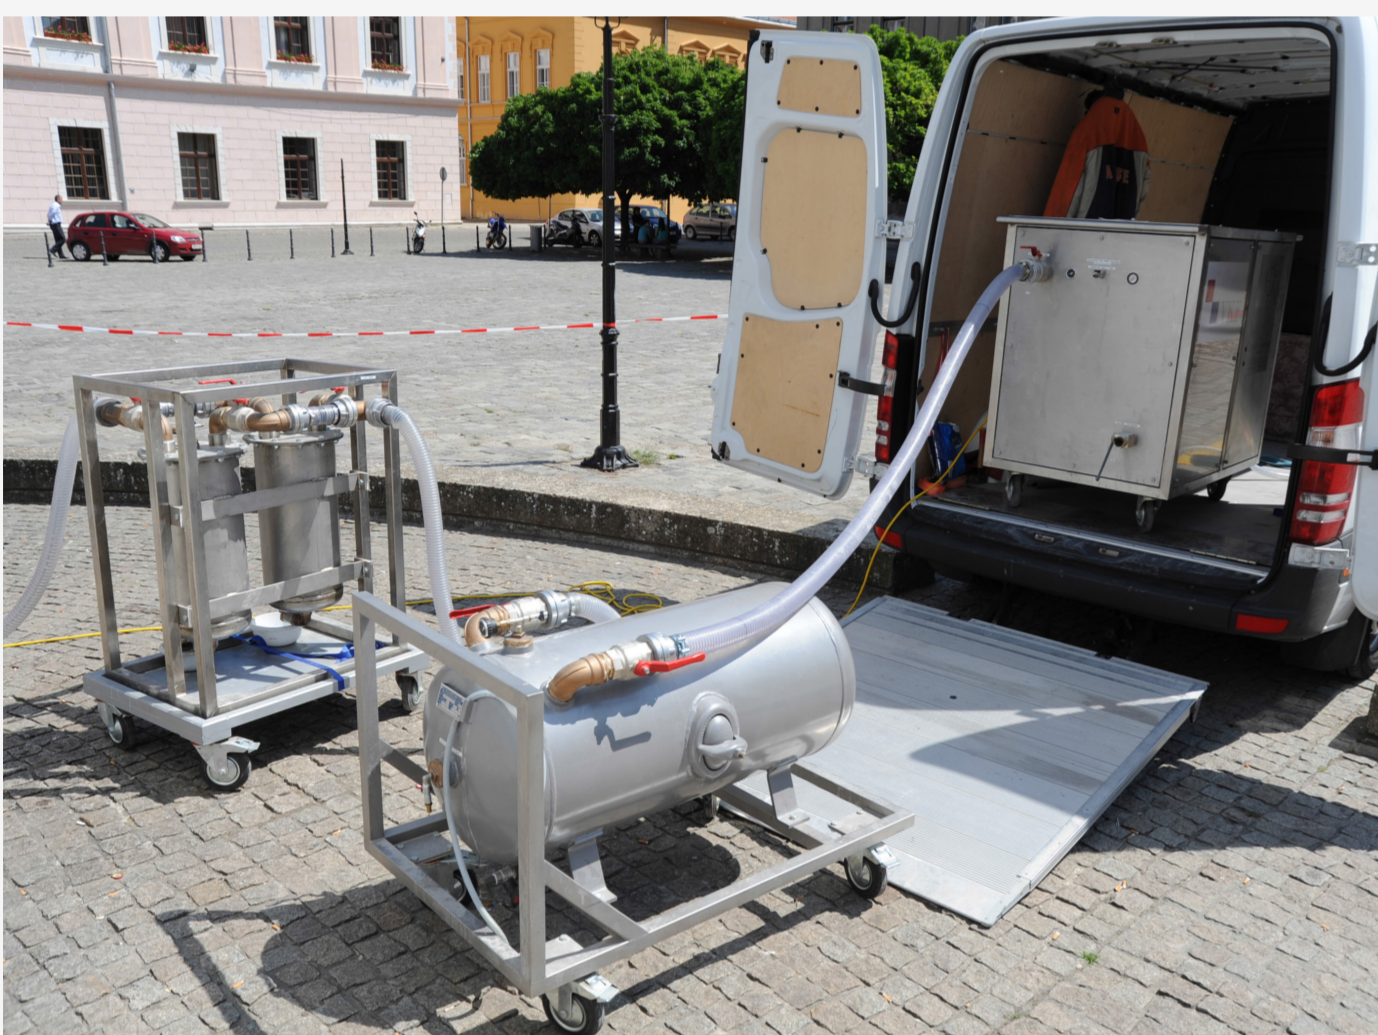
Figure 1: Mobile VCP equipment, vacuum pump (in truck), balance tank (middle), tank A&B combination (left; see Figure 2 for details).

The equipment is easily moveable and offers the possibility to conserve objects in any position or situation, on buildings or freestanding.

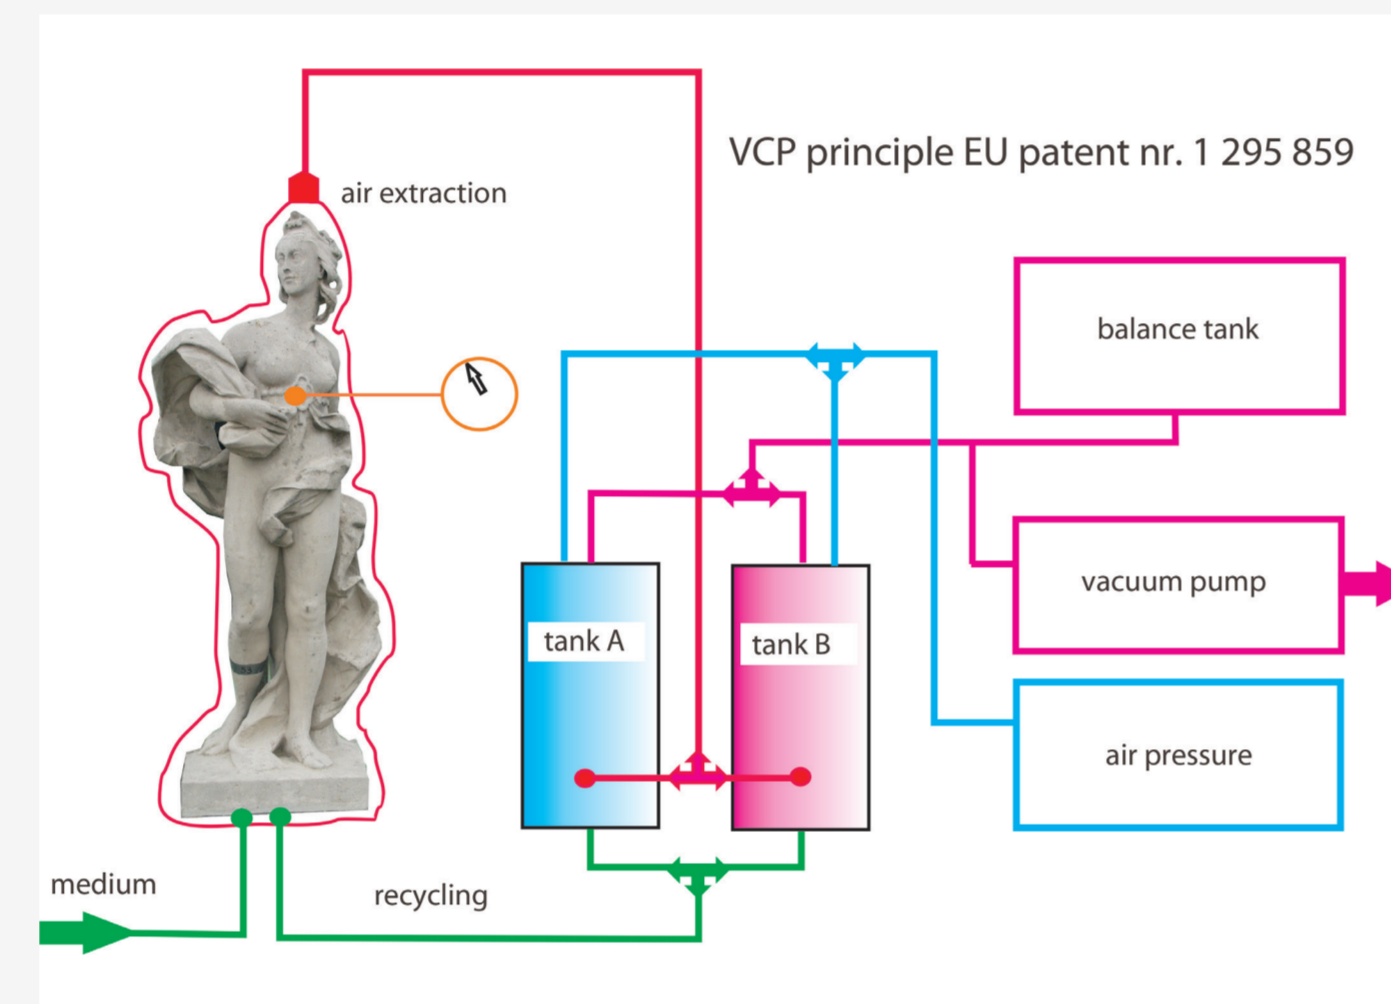
Figure 2: Principle of the vacuum circling process.

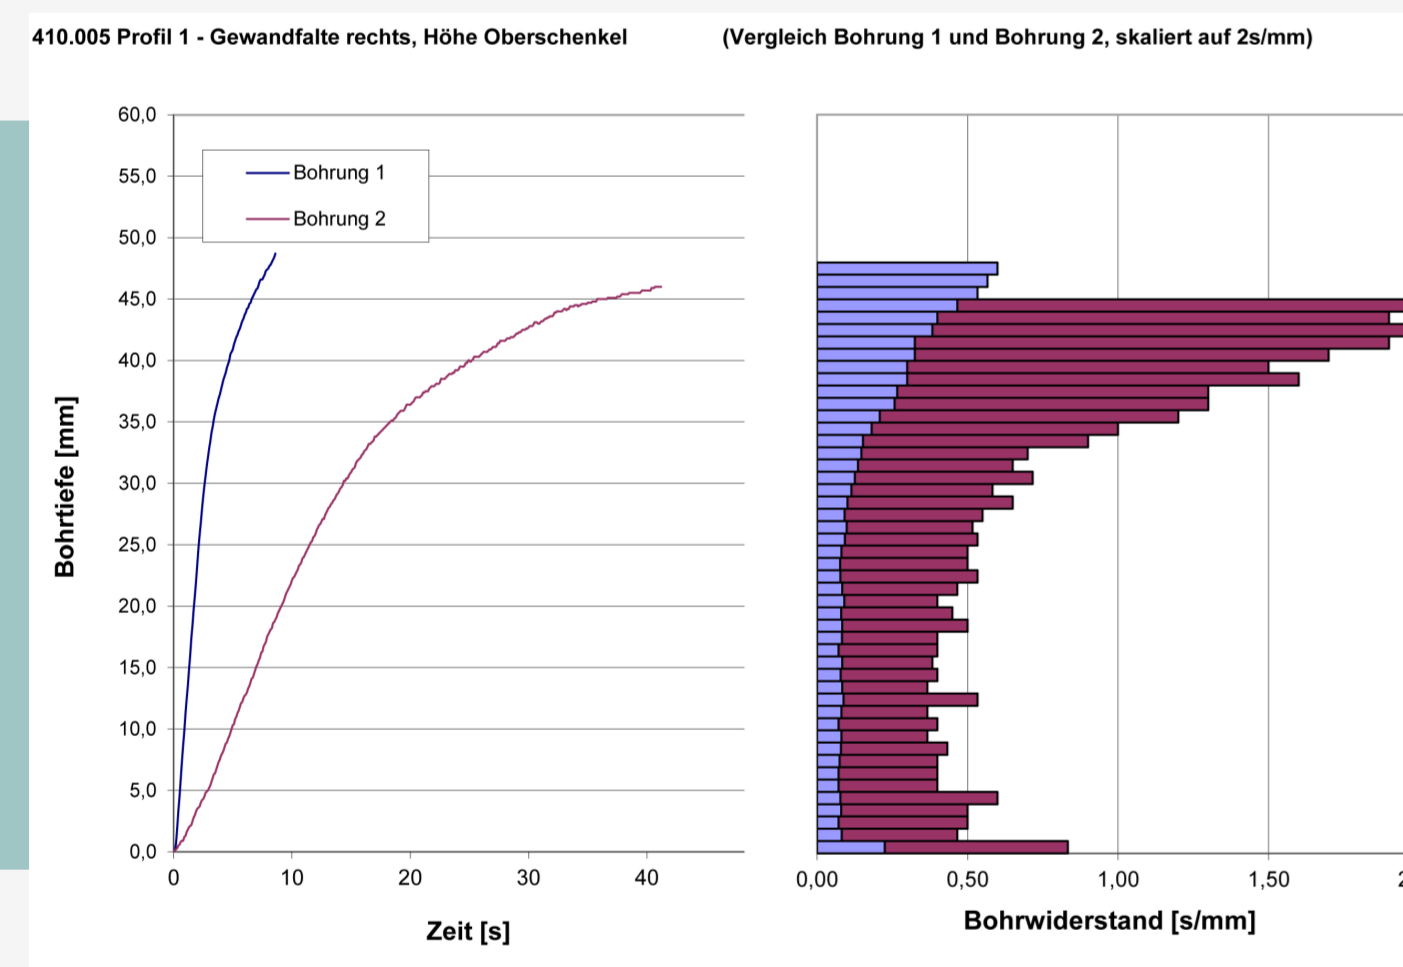
Figure 4: Garment fold right, high height, covered by several layers of oil paint, blue curve – before strengthening, red curve – after strengthening, scaled to 25/mm.

Drilling resistance profiles report the solidity in the different steps of depths. See figure 4 and 5 for examples of drilling resistance profiles. The analysis was done in steps of 1 mm; blue curve – before strengthening, red curve – after strengthening.

The results report the successful VCP treatment with ESE 300E. The increase in solidity has been achieved uniformly from the surface right into the depths.

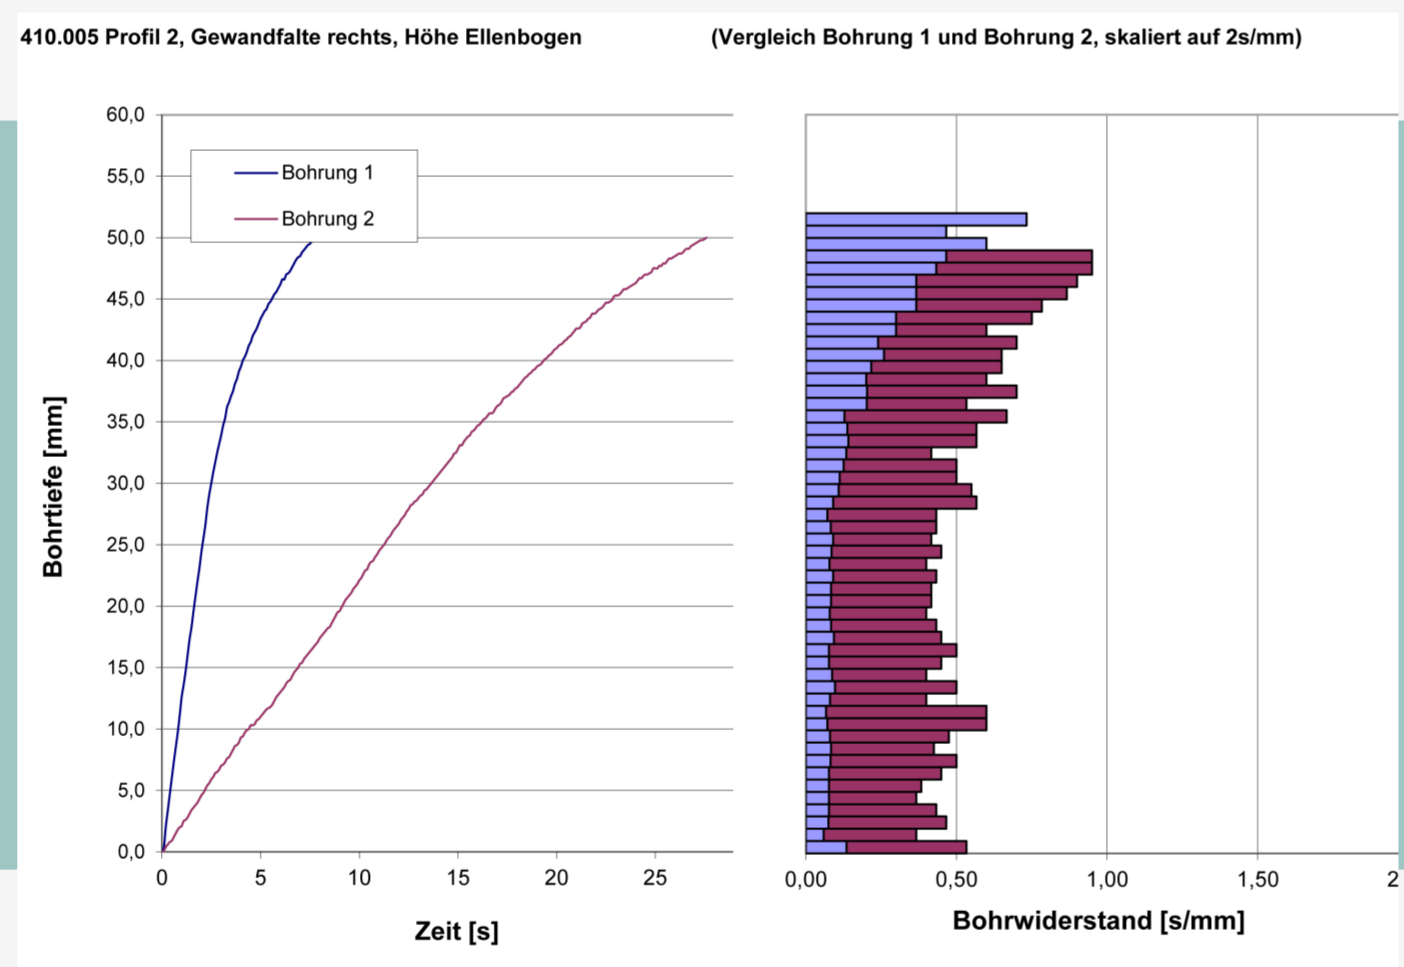
Figure 5: Garment fold right, elbow height, covered by several layers of oil paint, blue curve – before strengthening, red curve – after strengthening, scaled to 25/mm.

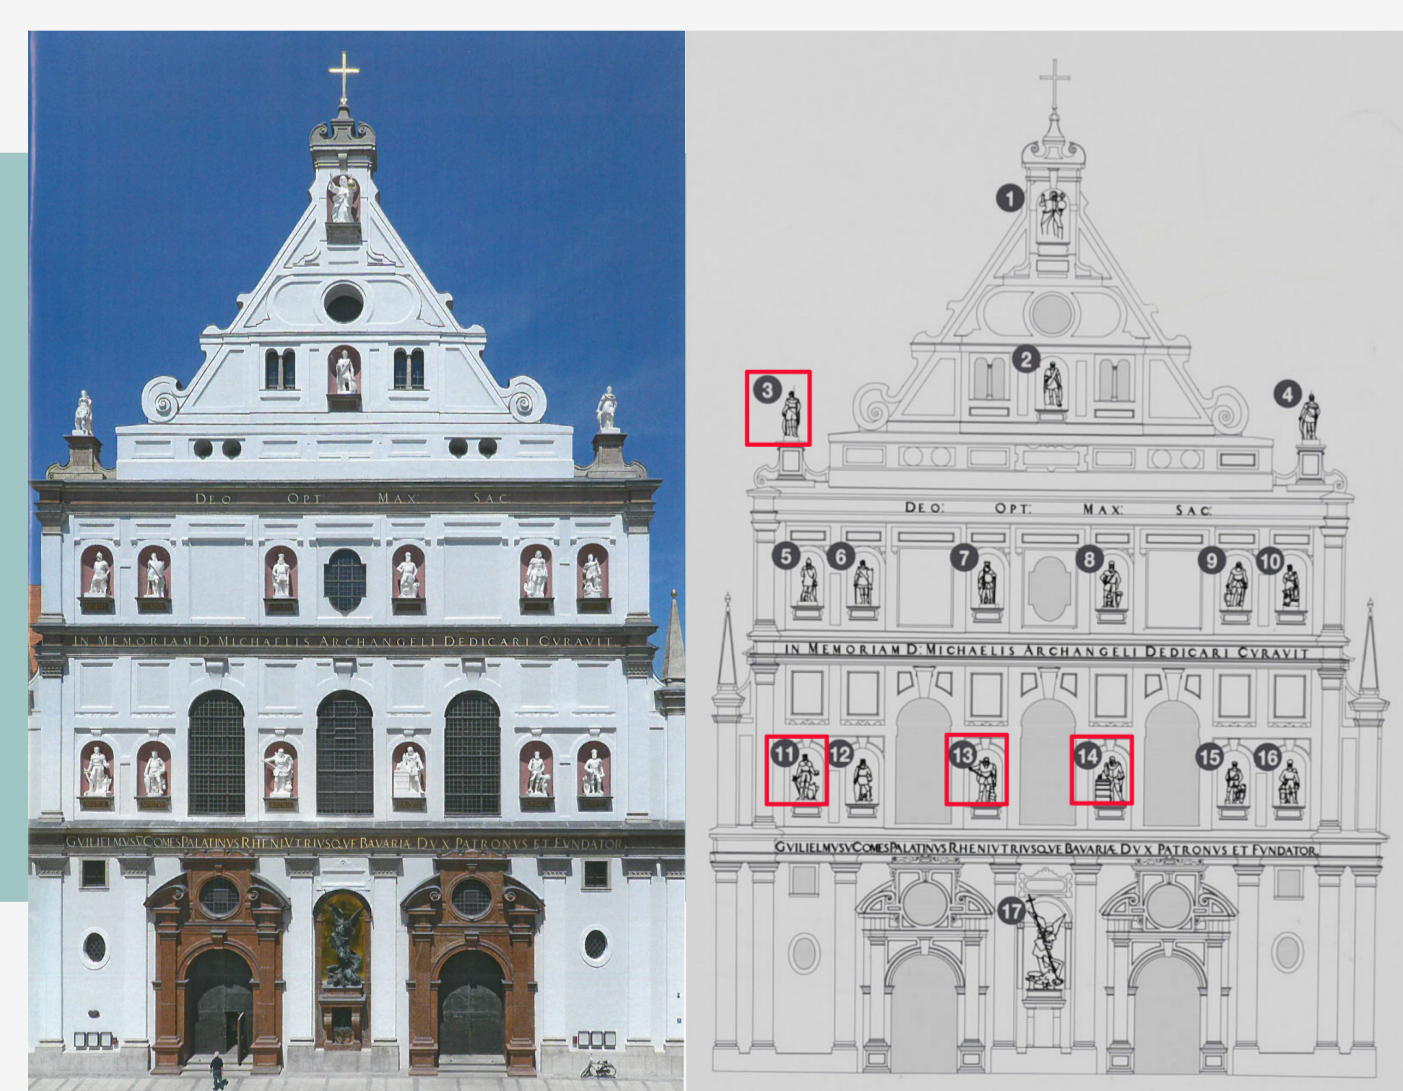
Figure 8: VCP conservation of four sovereign statues.

VCP conservation was implemented on four sovereign statues made of Euville limestone. These were: Theovalda, Duke Albrecht V., Duke Wilhelm V. and Emperor Maximilian I.

The conservation was carried out in situ without any movement of the statues, which had a height of 250 cm. The strengthened media were ESE 300E accelerated and 500E accelerated, applied in succession. (See Figure 8, 9 and 10)

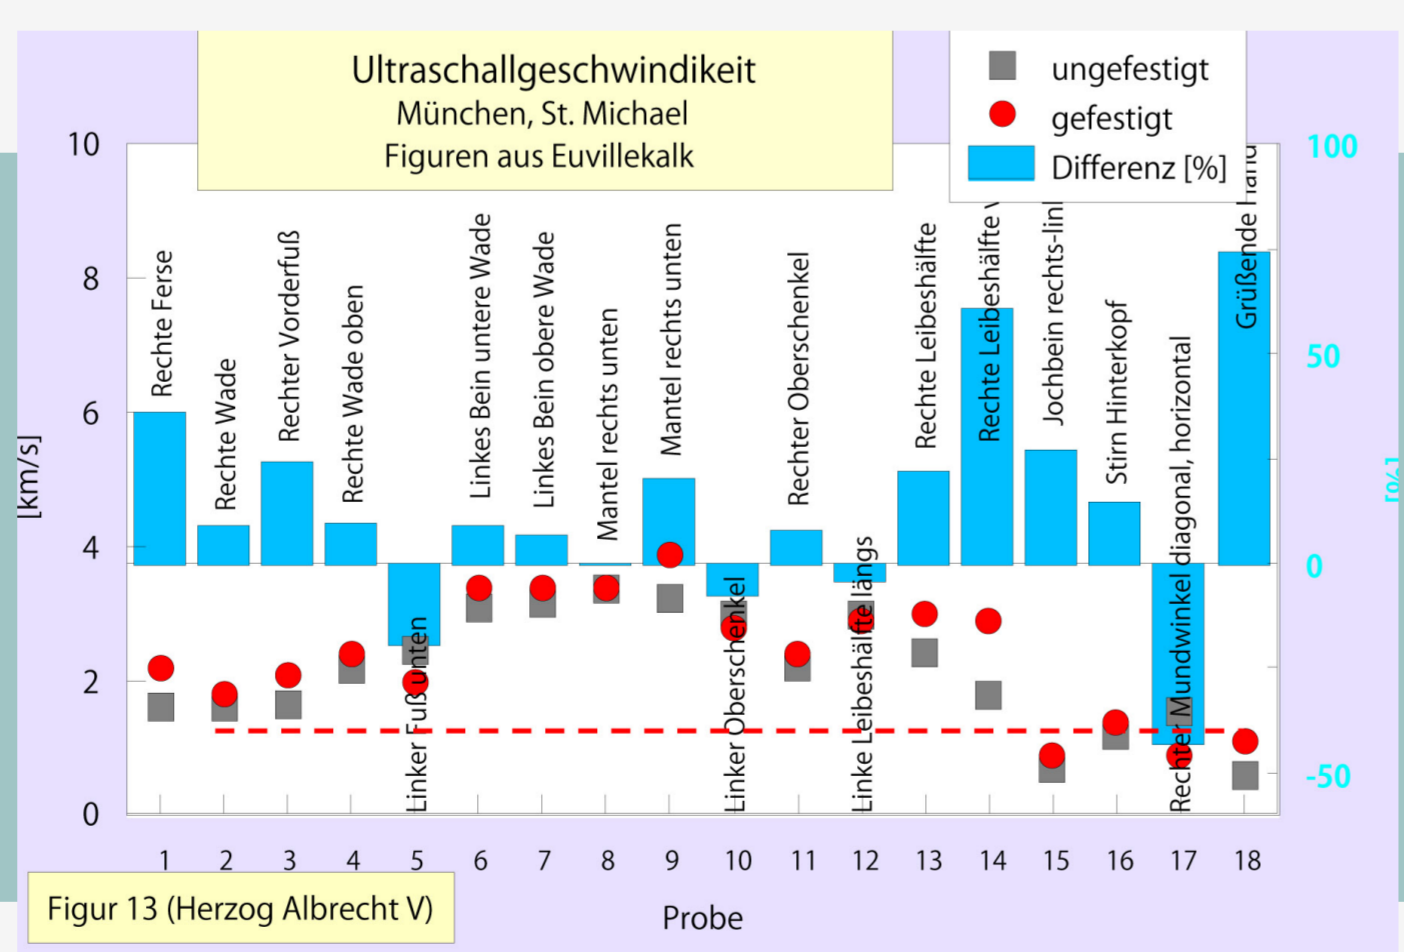
Figure 9: Duke Albrecht V., ultrasonic measurement report by Dr. Eberhard Wendler, Munich, St. Michael, (grey – not consolidated, red – consolidated, blue – difference).

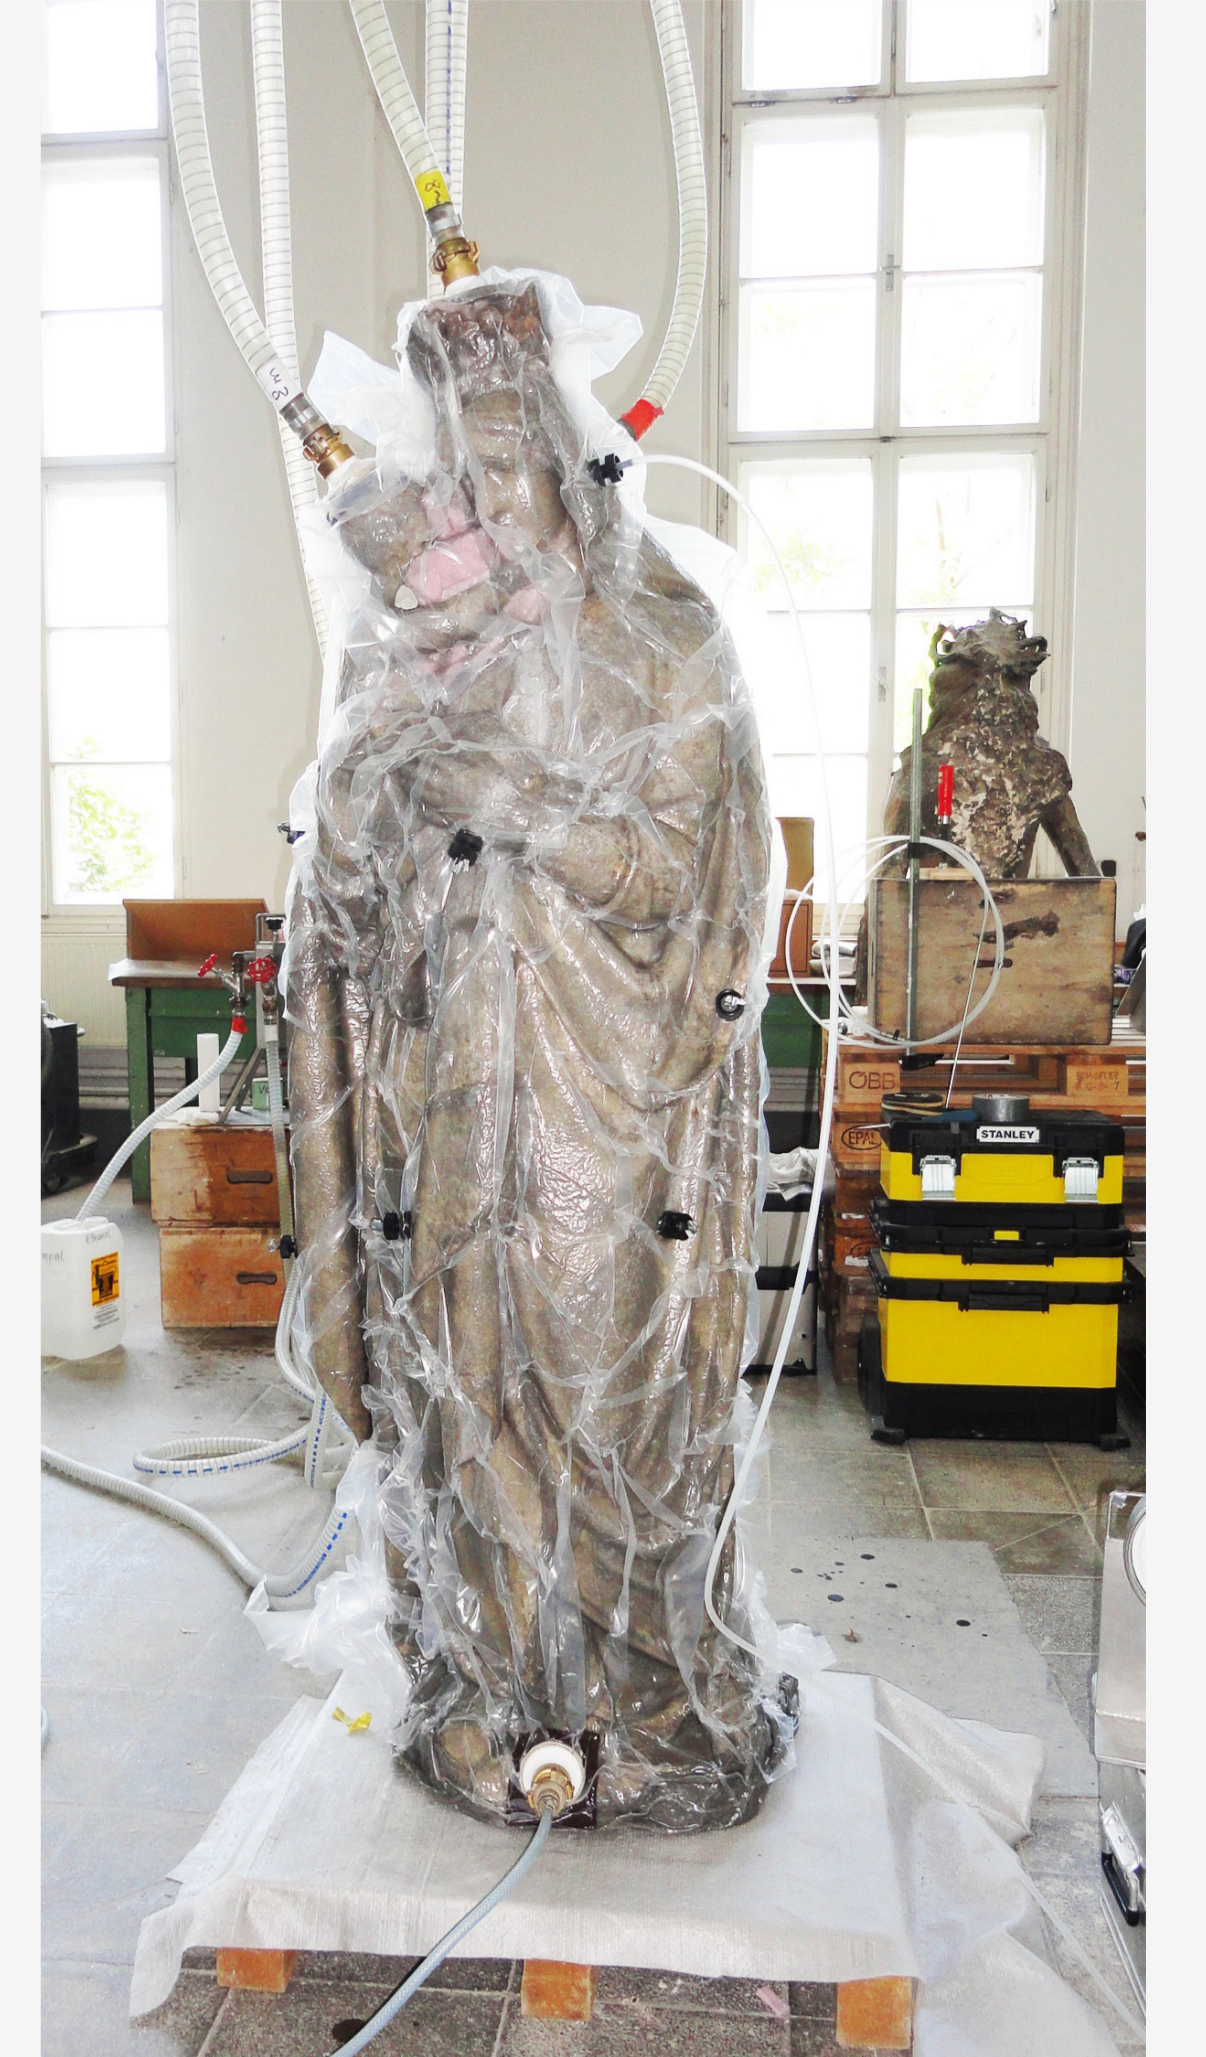
Figure 3: VCP treatment of the 160-cm-high statue.

The sculpture was situated on a facade in the 7<sup>th</sup> district of Vienna. It is sculptured in a very porous calcareous Arenite with an original polychrome executed using an oil technique. The sculpture was demounted and was transported to the restoration laboratory of the University of Applied Art. The conservation and restoration of this statue are the subject of a diploma thesis with the task of strengthening the inner structure of the Madonna, which is covered by several layers of oil paint (See "Ethyl-silicate consolidation for porous limestone coated with oil paint – a comparison of application methods / 2016" a paper for the 13<sup>th</sup> international congress on the deterioration and conservation of stone 2016; M. Milchin, J. Weber, G. Krist, E. Ghaffari, S. Karacsonyi). As a first step, the whole statue was wrapped in polypropylene fleece material. This material had the function of protecting the surface of the statue but also to avoid leaking of the polyethylene foil used to create the airtight environment. On the highest points of the statue, purging valves were fixed with the foil. At the lowest position, inflow valves were mounted. A manometer for controlling the negative pressure inside the foil was also connected. After evacuating the air, the inflow of the strengthened medium silica acid ester (ESE) 300E/accelerated began. The negative pressure inside the foil went up to 800 mb and lasted for the whole process of 6 hours. When no more medium was absorbed by the stone the degree of saturation was reached, controlled by measuring the backflow in the circular flow. As a result, 61 kg ESE was absorbed, despite the fact that the surface of the stone was covered by oil paint up to nearly 95 percent. The deep penetration took place through the cracks and small defects in the coating and also through the uncoated base. At the end of the treatment the excess medium was extracted by the lowest inflow valve. The surface was not left with any oversaturation because the fleece had the function of blotting paper and absorbed all surplus liquid. The reaction of the accelerated ESE usually requires a temperature-dependent time of 4–6 weeks. Because of the prompt start of the reaction, the ESE neither drained out nor sunk inside the stone.

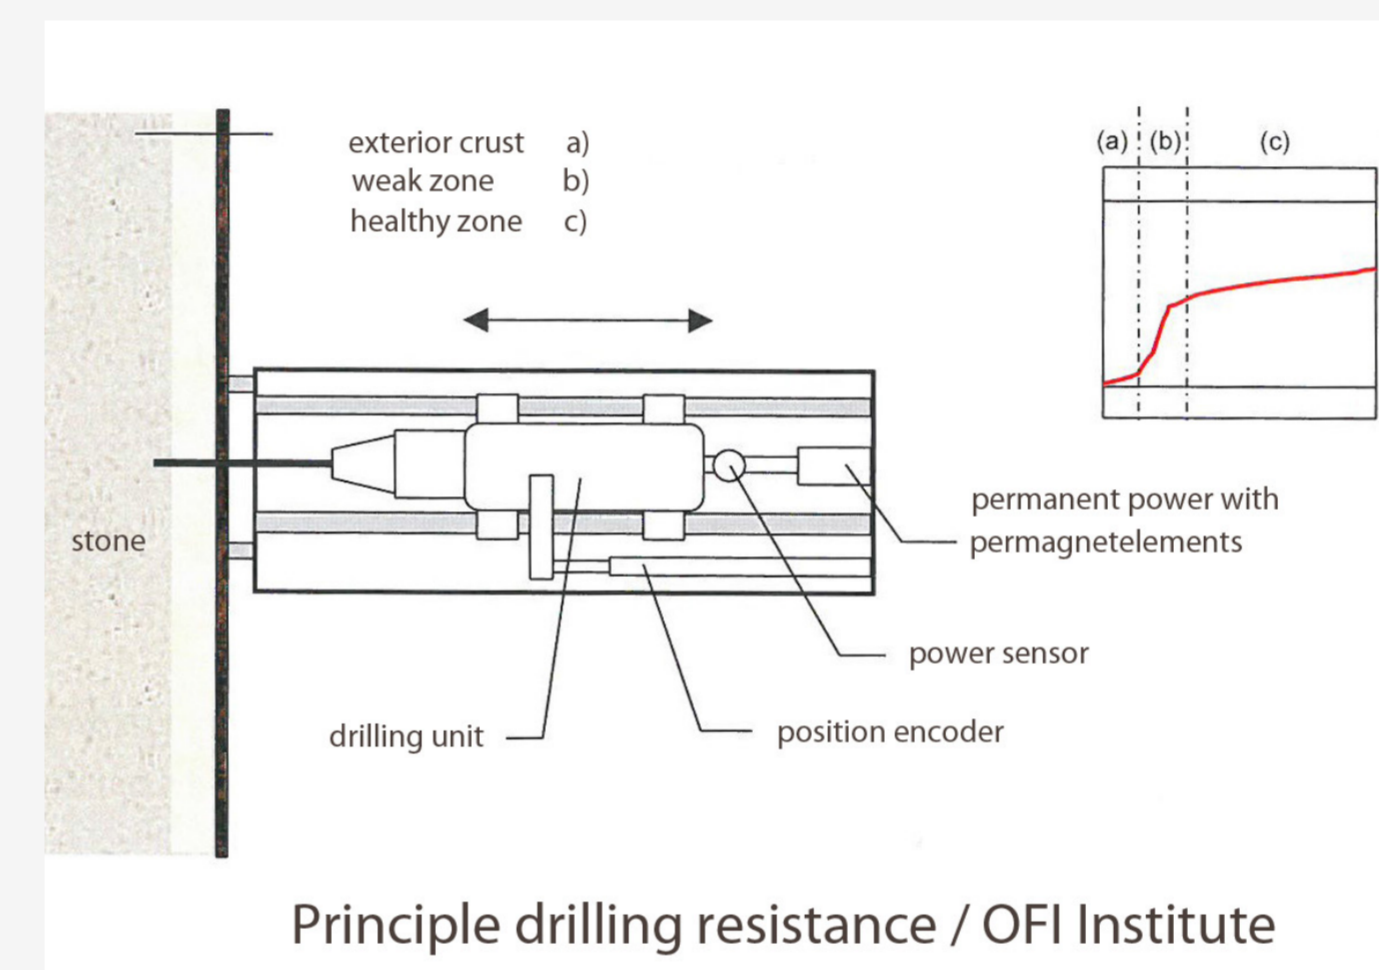
Figure 6: Principle drilling resistance, OFI Institute.

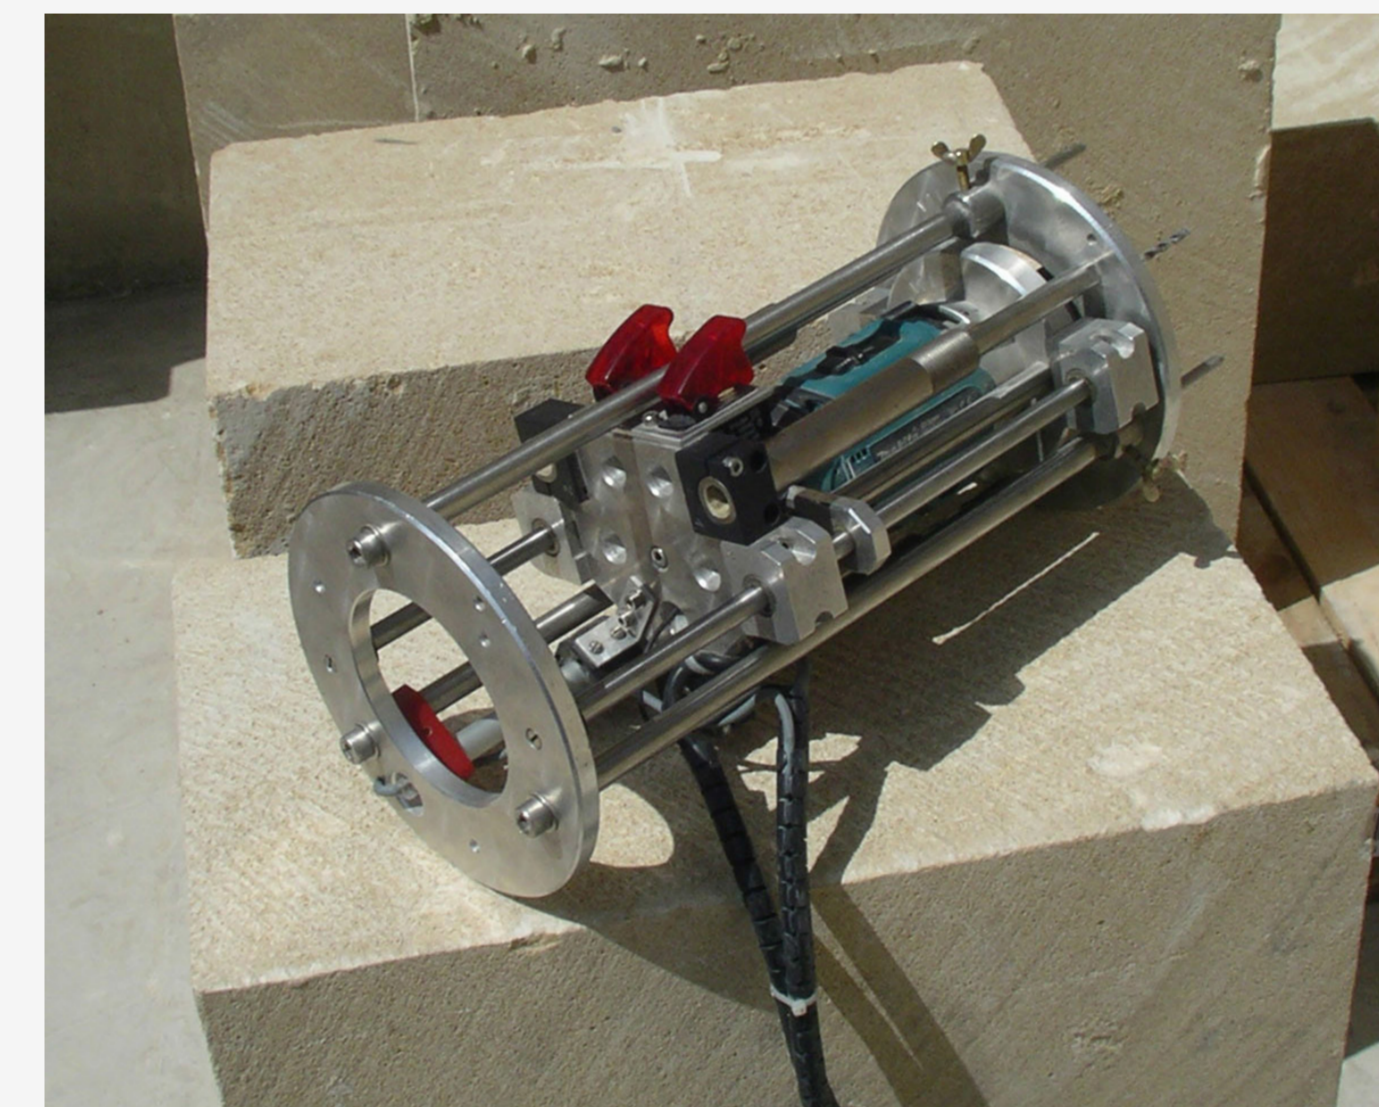
Figure 7: Drilling resistance device. Developed by Dr. Günther Fleischer, OFI Technologie & Innovation GmbH, Vienna.

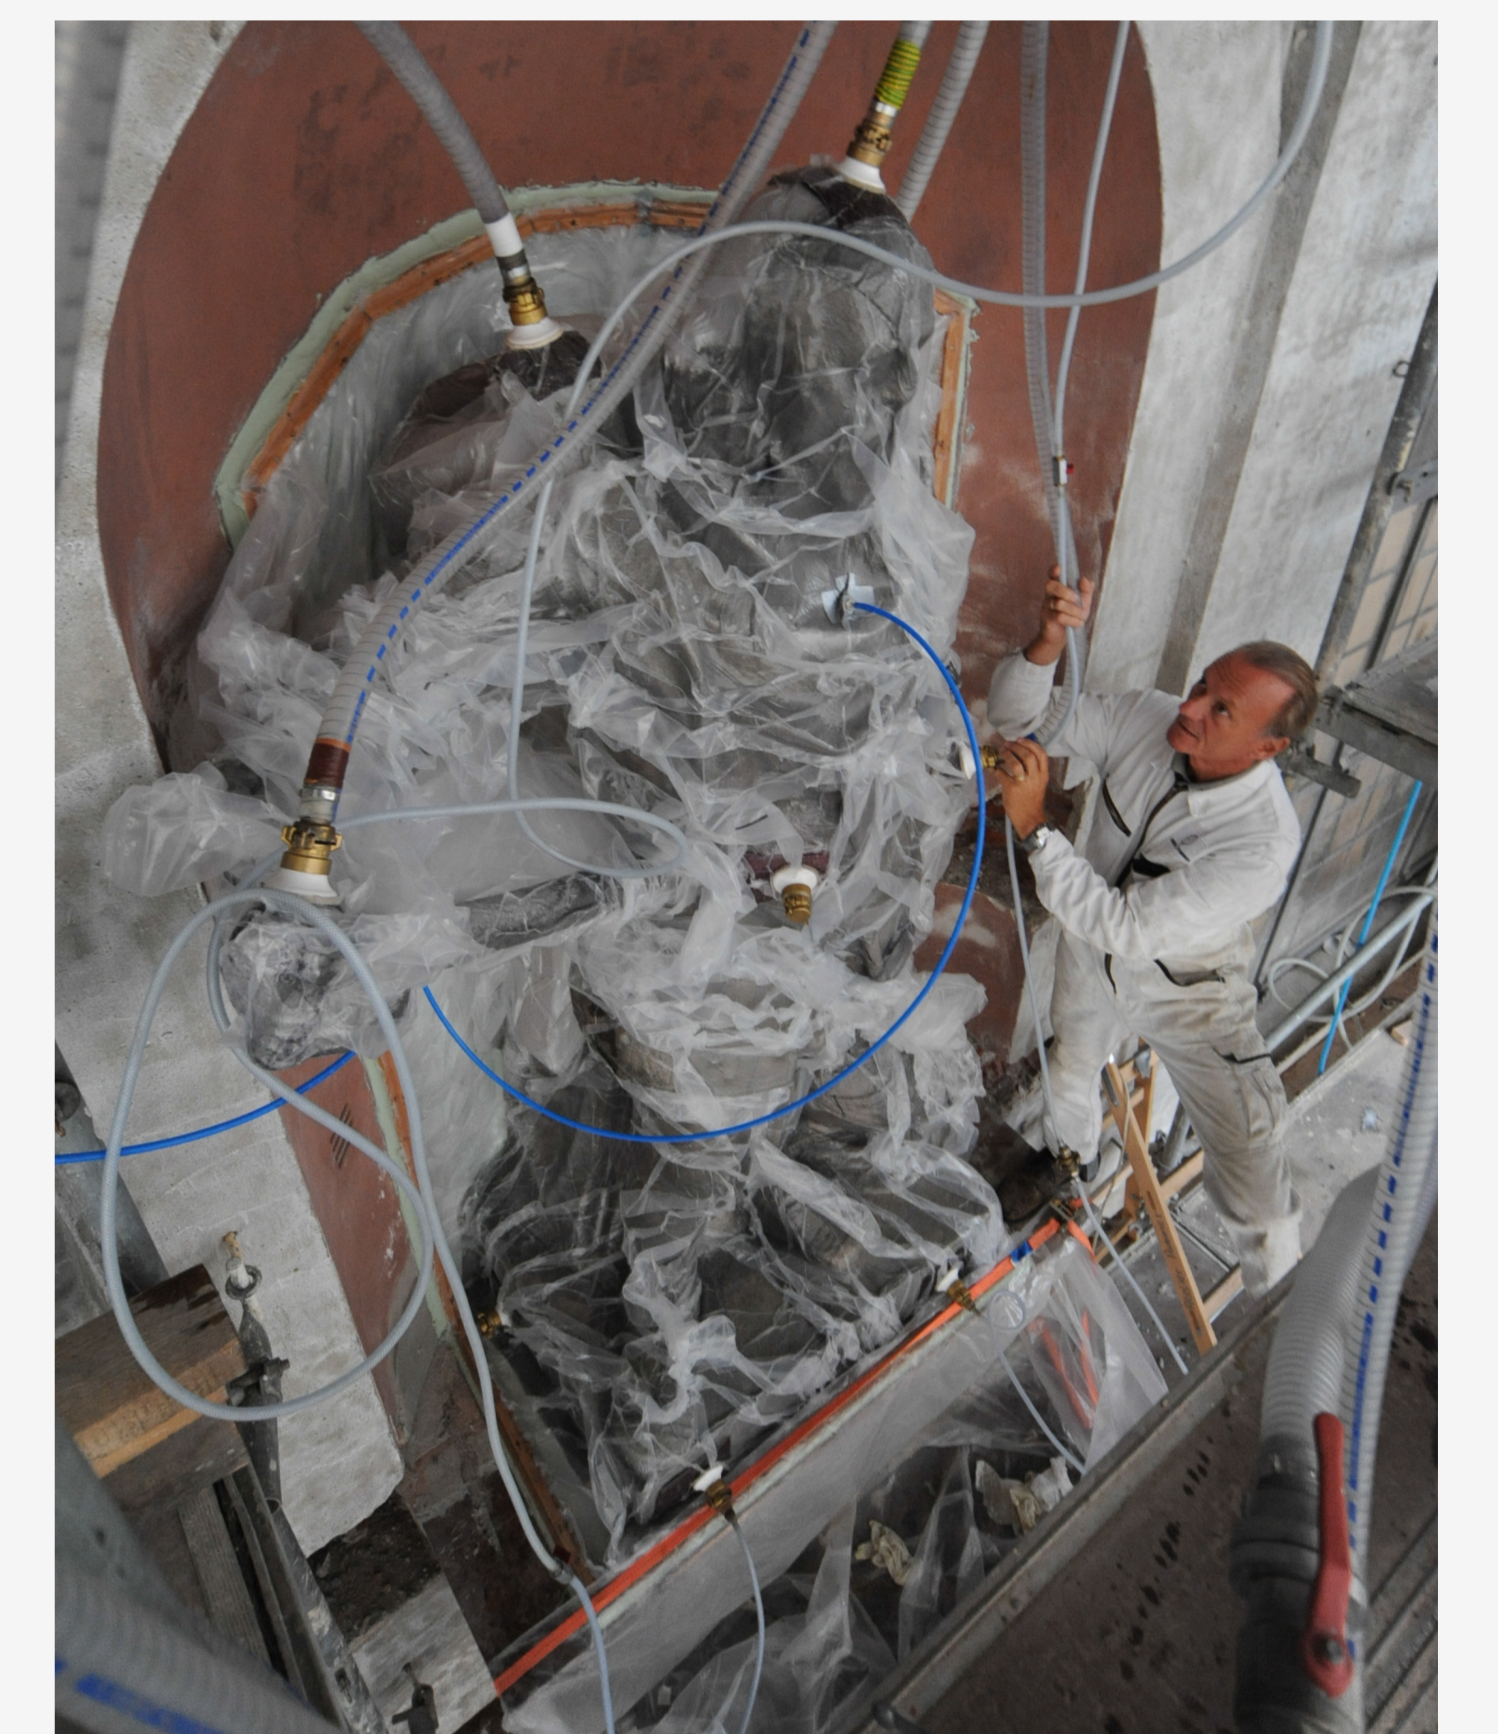
Figure 10: VCP conservation in situ of Duke Albrecht V., duration of treatment: 10 hours. Absorption of ESE: 50 kg.

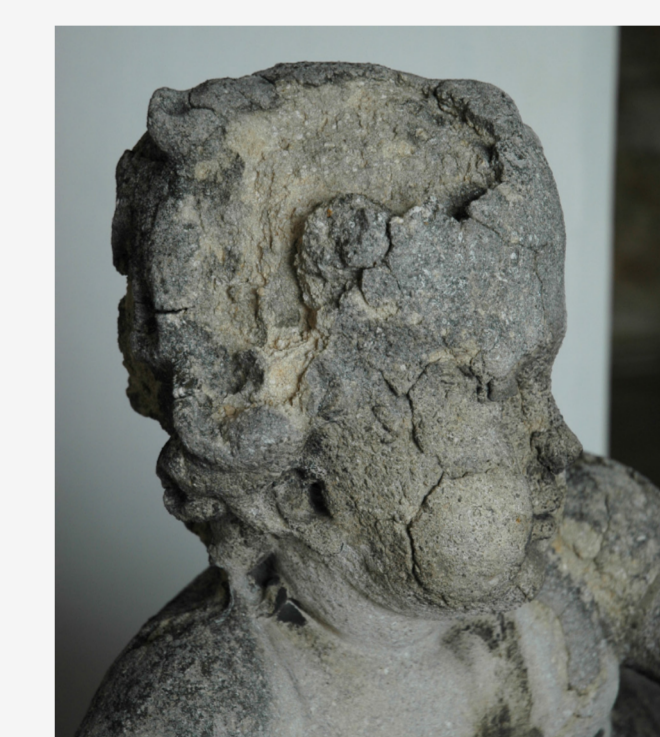
Figure 11: Photograph of a limestone statue, surface-treated with ESE 300 20 years ago.

Up to a depth of 10 mm the outside section is still conserved, but because of the different physical characteristics of treated and untreated stone, the outside section has lost coherence to the inner structure. Therefore the harder outside section shows spalling.
